RADIOLOGICAL FINAL STATUS SURVEY OF THE HAMMOND DEPOT HAMMOND, INDIANA

Oak Ridge Institute for Science and Education
Oak Ridge, Tennessee 37831-0117

FINAL REPORT

APRIL 2008

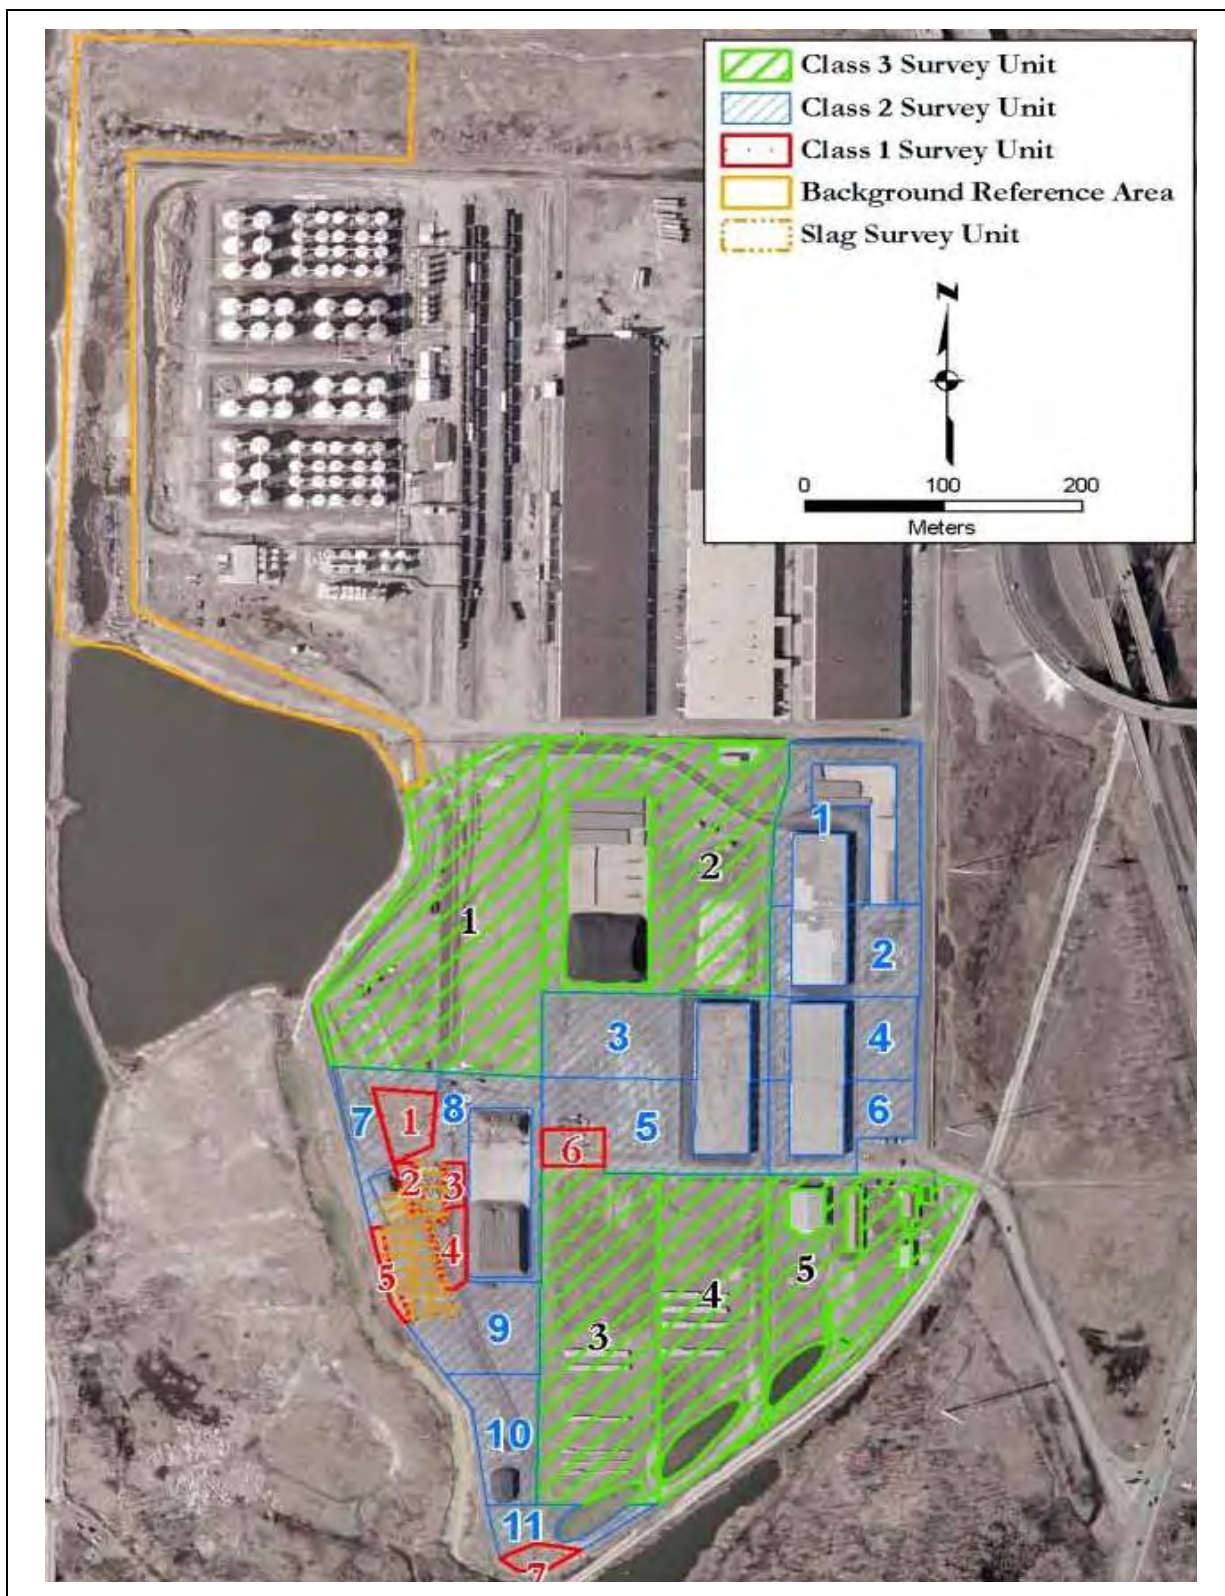
Figure A-2: Hammond Depot—Contaminated Buildings and Soil AOCs

The scoping and characterization surveys found extensive contamination on the floors of the south half of Building 200E where containers of ThN were stored and known to have leaked. The contamination was on the original concrete floor of the building, beneath the asphalt overlayment. Multiple small area and distributed locations of elevated gamma radiation were detected—indicating contamination beneath the asphalt—that ranged from 5,000 to 200,000 counts per minute (cpm). Investigations beneath the asphalt overlayment found that much of the contamination was associated with expansion joints and cracks in the original concrete floor slab. The contamination was also found to have migrated through these openings and spread to the monolithic slag layer that was immediately beneath the floor. Surveys confirmed the presence of contamination in excess of the $DCGL_w$ on overhead structural steel and pipes, support columns and bases, and isolated lower wall areas.

One area of contamination was identified in the closet area at the northwest end of Building 200E. Investigations identified jars of source material stored in the closet and one jar was noted to be leaking, causing localized floor and wall surface contamination.

Contaminated pallets were identified in Building 100E during the scoping survey within Bays 19 and 20. Once the pallets were surveyed and removed, the characterization survey identified three expansion joint locations with activity levels in excess of the $DCGL_w$. Also, the pallets of tannin contaminated with monazite sand were present at this time but were not found until the FSS, after other materials had been moved out of the way. It is believed that the monazite sand was also the source of the contamination found within the expansion joints.

Building 100E was remediated by first removing the contaminated pallets during the interim cleanup action. The contaminated expansion joints were chipped out. The pallets of tannin that were found contaminated with monazite sand during the FSS were wrapped and disposed of as waste. The surrounding floor was vacuumed and an associated expansion joint required removal of the mastic and concrete.
